UNDERWATER BRIDGE INSPECTION REPORT

STRUCTURE NO. 84524
CSAH NO. 32
OVER THE
BUFFALO RIVER
DISTRICT 4 - WILKIN COUNTY

PREPARED FOR THE
MINNESOTA DEPARTMENT OF TRANSPORTATION
BY
COLLINS ENGINEERS, INC.
JOB NO. 3512

MINNESOTA DEPARTMENT OF TRANSPORTATION
UNDERWATER BRIDGE INSPECTION

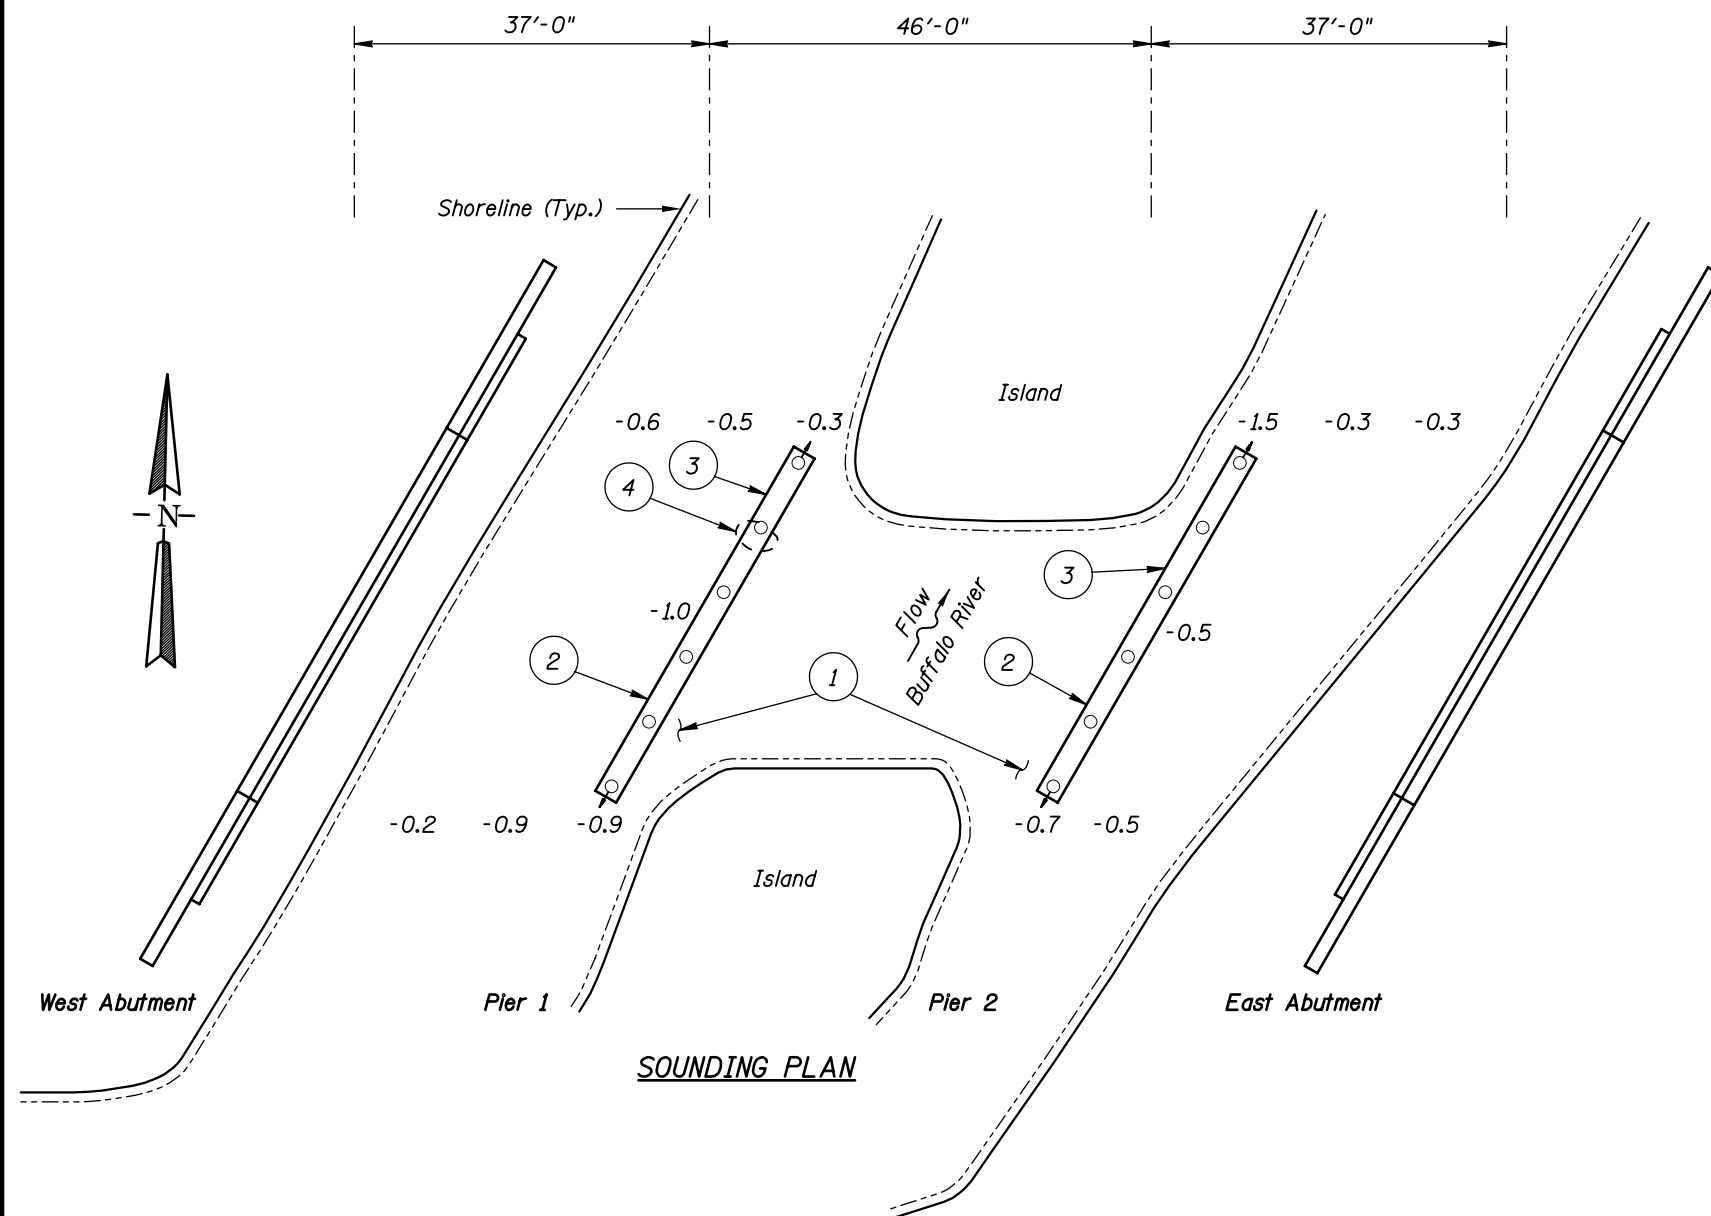
INSPECTION AND SOUNDING PLAN

- 1 The channel bottom around both piers consisted of soft silt, sand, and random stones with up to 2 feet of probe rod penetration.
- 2 Piers 1 and 2 exhibited coating loss from 1.5 feet above the waterline to the mudline. There was minimal deterioration of the steel related to the coating failure
- 3 Minor scour depressions were observed around most of the piles and typically exhibited 6 to 12 inches of depth.
- 4 Scour depression was observed that had a 2 foot radius and was up to 1 foot deep.

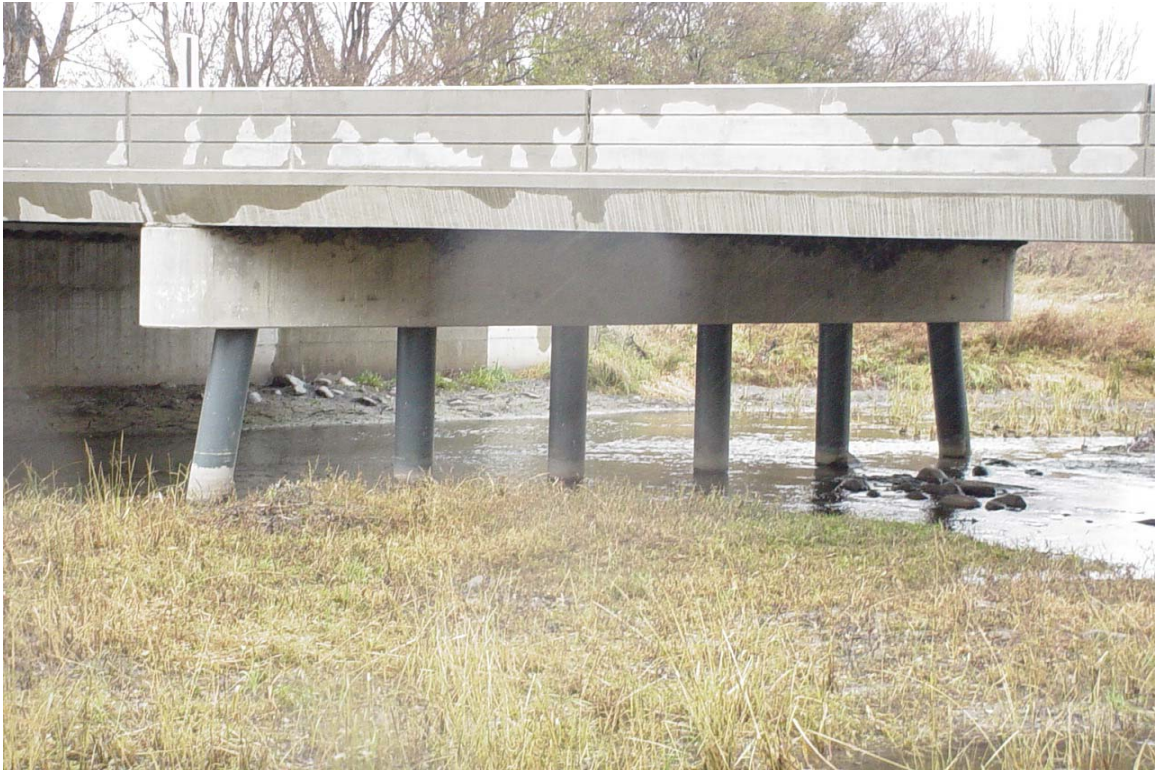
Photograph 3. View of Pier 1, Looking Northwest.

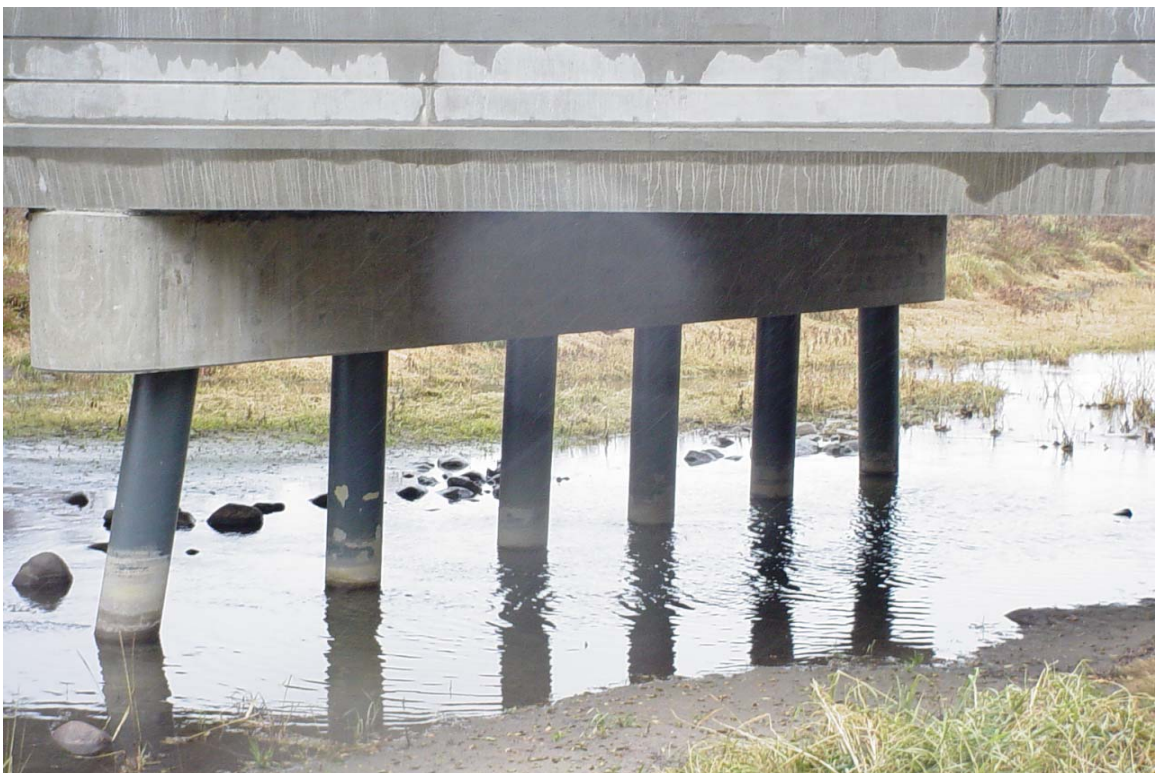
Photograph 4. View of Pier 2, Looking Northwest.
